# Manhole Inspection Summary

Manhole # S27C\_\_021MH

Insp Date: **12/4/07 3:27 PM**

**Location** Address: **901 BENNETT-FRANKLIN AL** Cross Street: **FREMONT AVE**

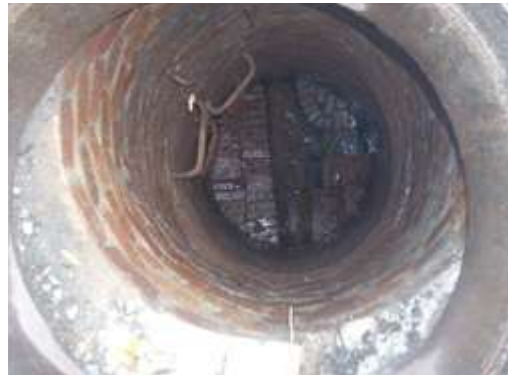
Defect 2

**Steps** Count: **4** Missing: **2** ☒ **Corroded**

CORRODED STEPS

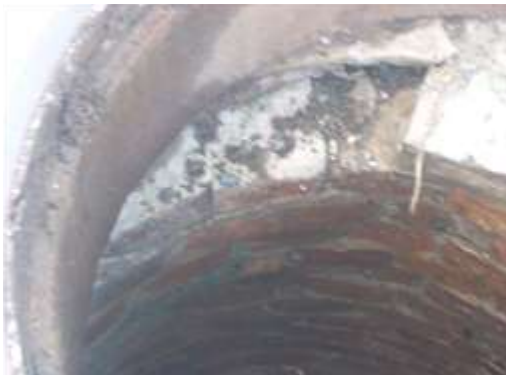
Defect 1

**Chimney / Frame Adjustment** ☒ Exists Material: **Brick** ☐ Parged Height: **3** (in.)  
Condition: ☐ Sound ☐ Cracked ☐ Root Intrusion ☐ Loose Brick ☒ **Deteriorated**  
Infiltration: ☒ None ☐ Joint ☐ Cracks ☐ Mortar ☐ Roots ☐ Wall

CHIMNEY DETERIORATION

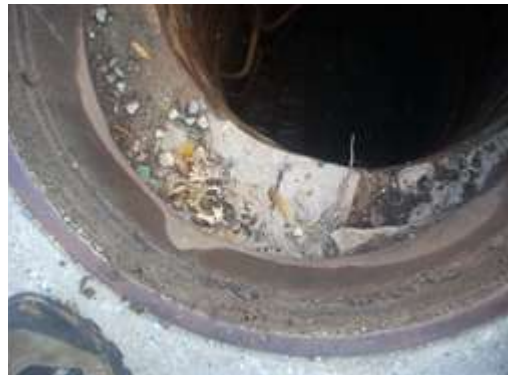
**Frame** Offset: **6** (in.) Condition: ☒ Sound ☐ Cracked ☐ Leaks

FRAME OFFSET

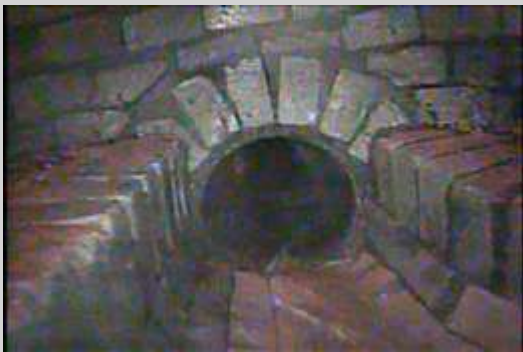
12 O'Clock Outflow

Pipe Height: **8.4** (in.) Rod and Bar (Angled)  
Pipe Material: **Clay** ☐ Pipe Lined  
Invert Depth: **13.06** (ft.) Flow Characteristics: **Slow**  
Deposits: ☒ None ☐ Mud ☐ Sludge ☐ Debris ☐ Grease  
Silt Depth: (in.) Deposits Extent:  
Infiltration: **None** Pipe Seal Cond: **Sound**

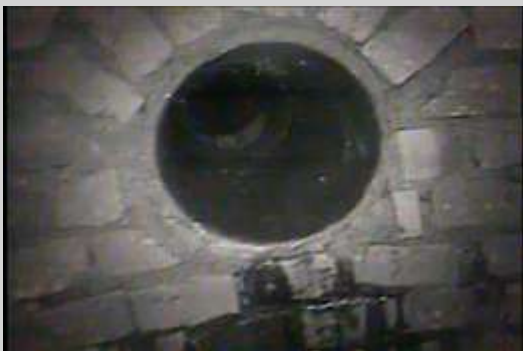
3 O'Clock Inflow

Pipe Height: **8.4** (in.) Rod and Bar (Angled)  
Pipe Material: **Clay** ☐ Pipe Lined  
Invert Depth: **9.83** (ft.) Flow Characteristics: **Fast**  
Deposits: ☒ None ☐ Mud ☐ Sludge ☐ Debris ☐ Grease  
Silt Depth: (in.) Deposits Extent:  
Infiltration: **None** Pipe Seal Cond: **Sound**

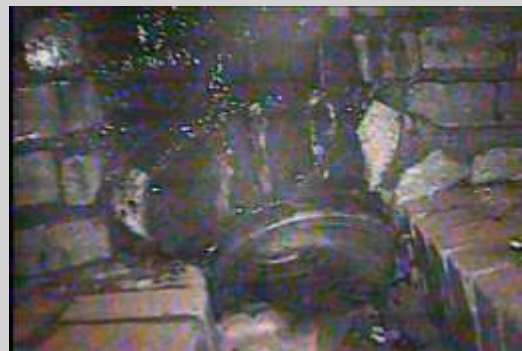
Drop In @ 3 O'Clock

Drop: **Outside** Rod and Bar  
Angled: **Yes** Reading: **11.80** (ft.)  
Inv Depth: **12.80** (ft.)  
Drop Condition: **Open**
